## Assessing the Integrity of Spillway Foundations

Chih-Hung Chiang<sup>1,2</sup>, **Keng-Tsang Hsu**<sup>1,2</sup>, Chia-Chi Cheng<sup>1,2</sup>, <sup>1</sup>Center for NDT, Chaoyang Univ. of Technology; <sup>2</sup>Dept. of Construction Engineering, Chaoyang Univ. of Technology, 168 Gifong E. Rd., Wufong, Taichung 41349, Taiwan

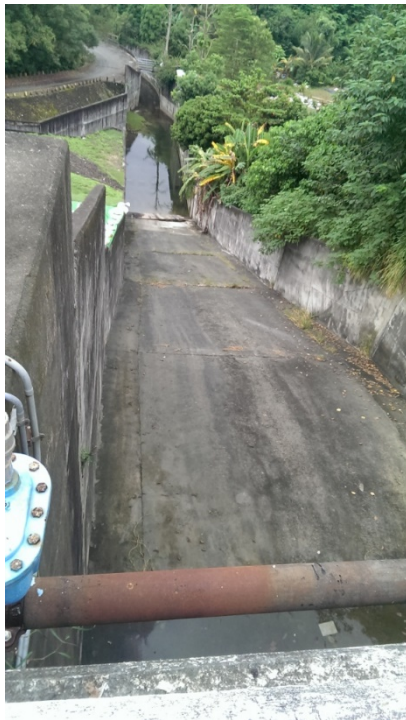
Figure 1

The erosion under a spillway can be a long-term issue that threatens the structural integrity of a water reservoir. The spillway under investigation was suspected to be defective after it had been commissioned in 1987 (Figure 1). Potholes and subsurface cavities were confirmed in the safety assessment using various NDT techniques including ground penetrating radar and impact echo. The GPR inspection was able to differentiate the intact region from the cavities under concrete slabs (Figure 2). The impact echo results and associated analyses provided further evidence of inferior condition in the soil under the concrete slabs. The engineering team designed and executed the repair project based on the conclusion of the integrity assessment. Subsequent GPR inspection has been performed so as to monitor the integrity of the spillway in a period of 18 months following the repair.
